**CRITICAL DESIGN REVIEW
UH-1N HELICOPTER RESCUE HOIST**

TECHNICAL REPORT ASD-TR-73-25

JULY 1973

AERONAUTICAL SYSTEMS DIVISION
AIR FORCE SYSTEMS COMMAND
WRIGHT-PATTERSON AIR FORCE BASE, OHIO

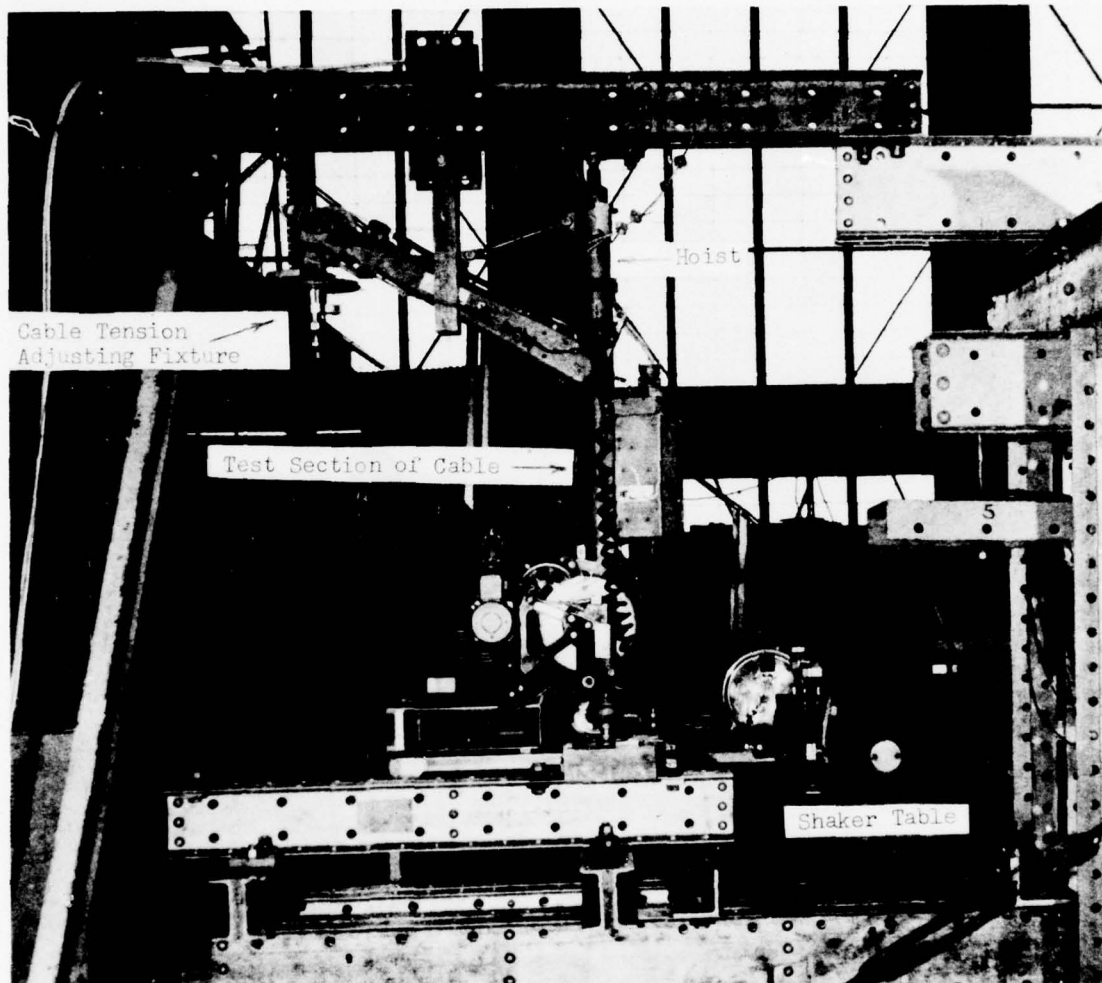
Figure 8 VIBRATION TEST

4. Vibration Test - This test was run to determine if helicopter vibration could contribute to cable failure through wear/fatigue (App I, Fig 8). The test was run at 50 cps because the UH-1F vibrational test data indicated that at 50 cps the greatest vibration amplitude (.008 inches) was present. A cable tension of 116 pounds was used because this caused the cable between the inboard pulley and the primary capstan to resonate. The hoist was vibrated for five hours for a total of 900,000 vibrational cycles. A section of cable, including both pulley and capstan tangencies, was taken and broken, using test method 2. The cable broke at 2,900 pounds tension. Three base line samples which had previously been taken broke at 3,510, 3,070, and 3,195 pounds. Thus, there appears to be some minor cable strength degradation but not a significant amount. The hoist functioned perfectly at the completion of the vibration test.

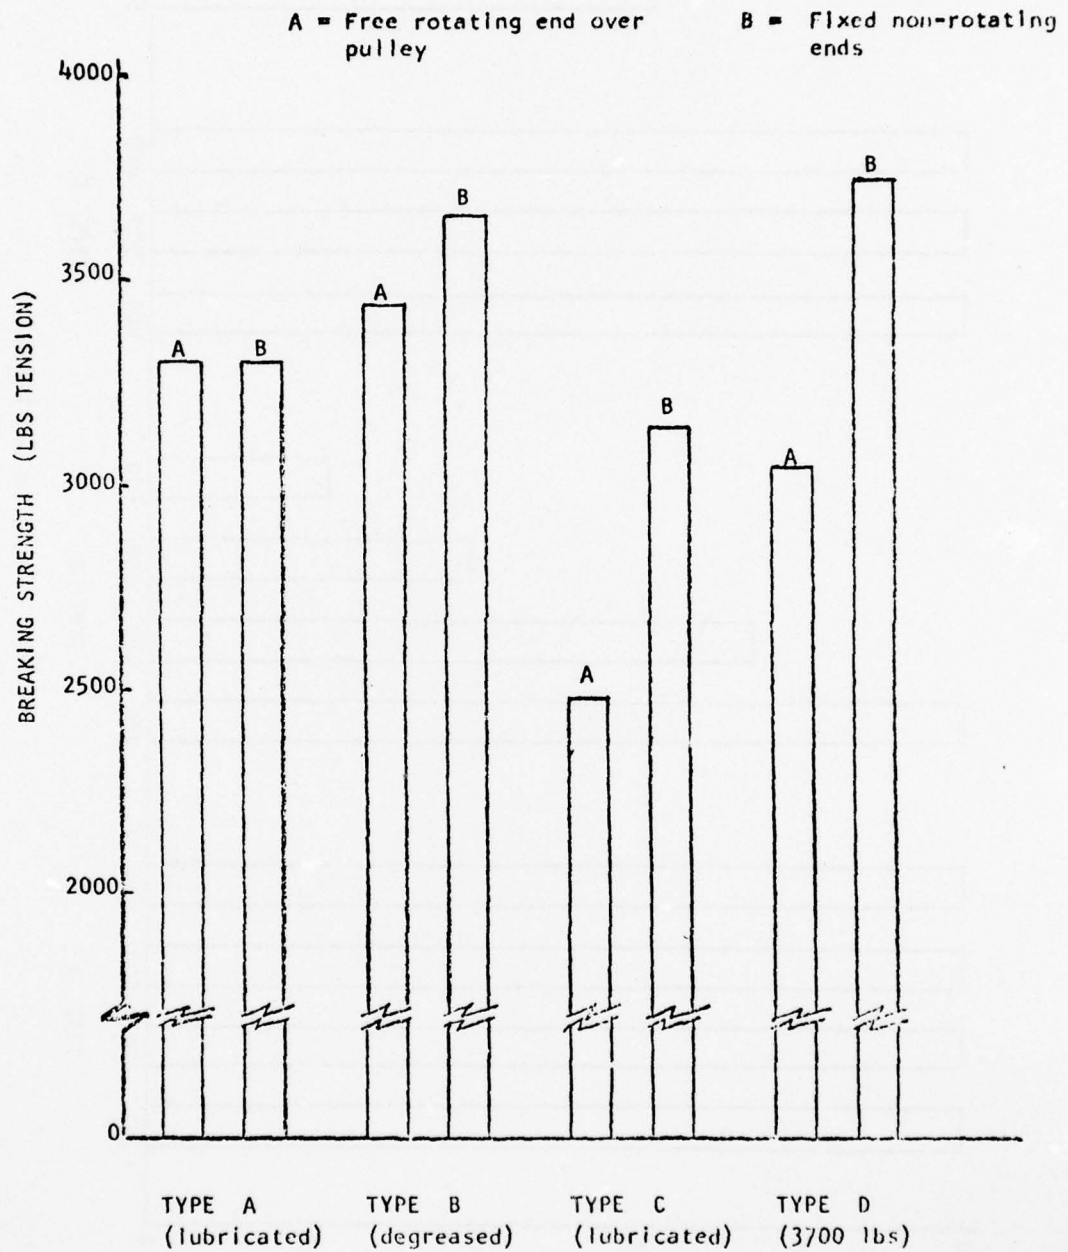
Figure 4 COMPARISON OF CABLE BREAKING TECHNIQUES

e. The method of breaking cables as presently contained in MIL-W-83140 is not representative of true cable strength in the UH-1N hoist applications. Our testing used a free end set-up which showed a decrease in cable strength of approximately 10-25 percent in some cases, which is considered significant. This phenomenon is characteristic of non-rotating or spin resistant cable due to its construction in that a certain amount of torque is developed when the cable is under a tensile load. If one end of the cable is free to rotate, a torque unbalance occurs which tends to tighten the inner strand lay and unwrap the outer lay strands. If the unbalance is significant, the result is a large decrease in ultimate breaking strength. The degree of torque unbalance generated varies directly with tensile load and appears to be primarily dependent on the ability of the contractor to obtain a uniform and stable torque-balanced cable construction during manufacturing. Consequently, since each contractor uses a unique set of wire sizes, wire material, strand lays, and rope lays, somewhat different characteristics are obtained, depending on the source of the cable. Figure 4 readily shows these differences.

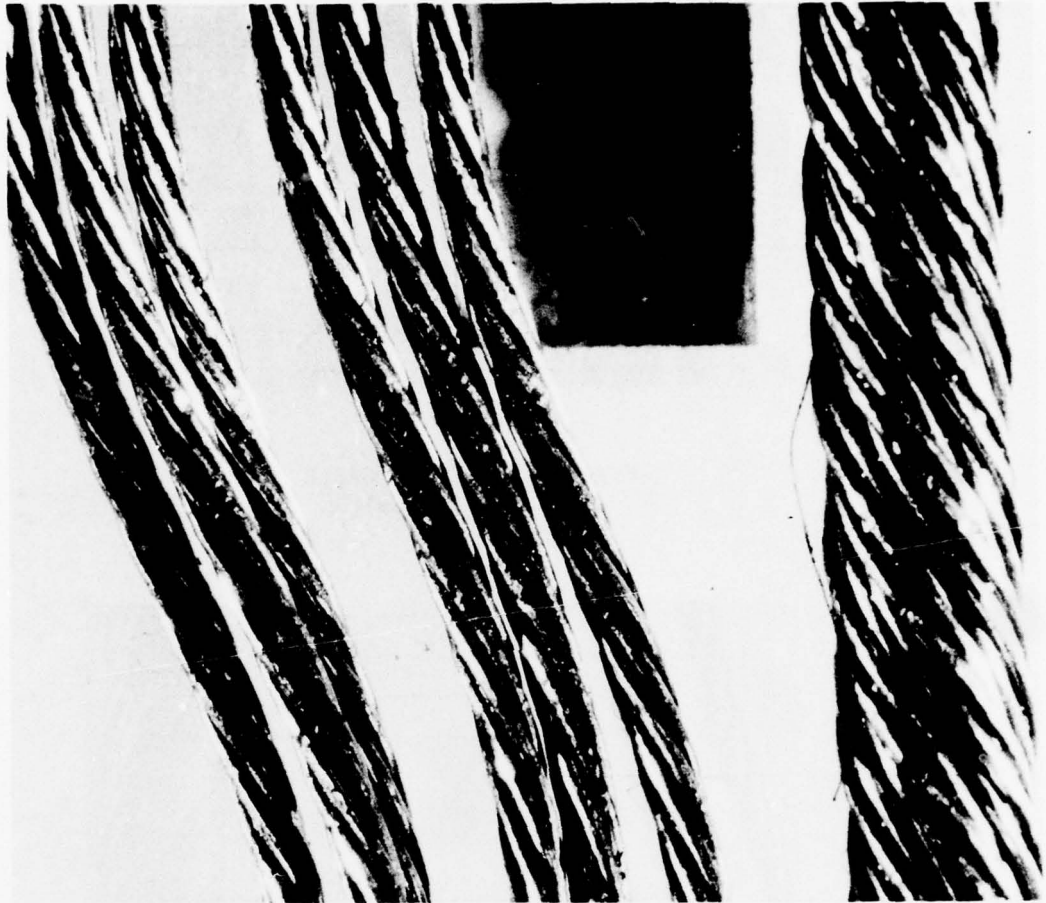
Figure 6 TYPE A CABLE
(50,000 Cycles)

d. The fatigue characteristics (strength degradation) of the cables tested appeared to be influenced to a large degree by cable ductility, cable manufacturing methods, and individual strand properties in lieu of initial breaking strength. Cables A and C showed a minimum strength reduction after endurance testing, while cables B and D failed to complete the testing at higher tension loads. It is interesting to note that cables B and D were also the cables which had the higher initial breaking strength when tested with fixed end attachment. The conclusion may be drawn that a higher initial cable breaking strength which sacrifices ductility tends to show poor fatigue life capabilities.

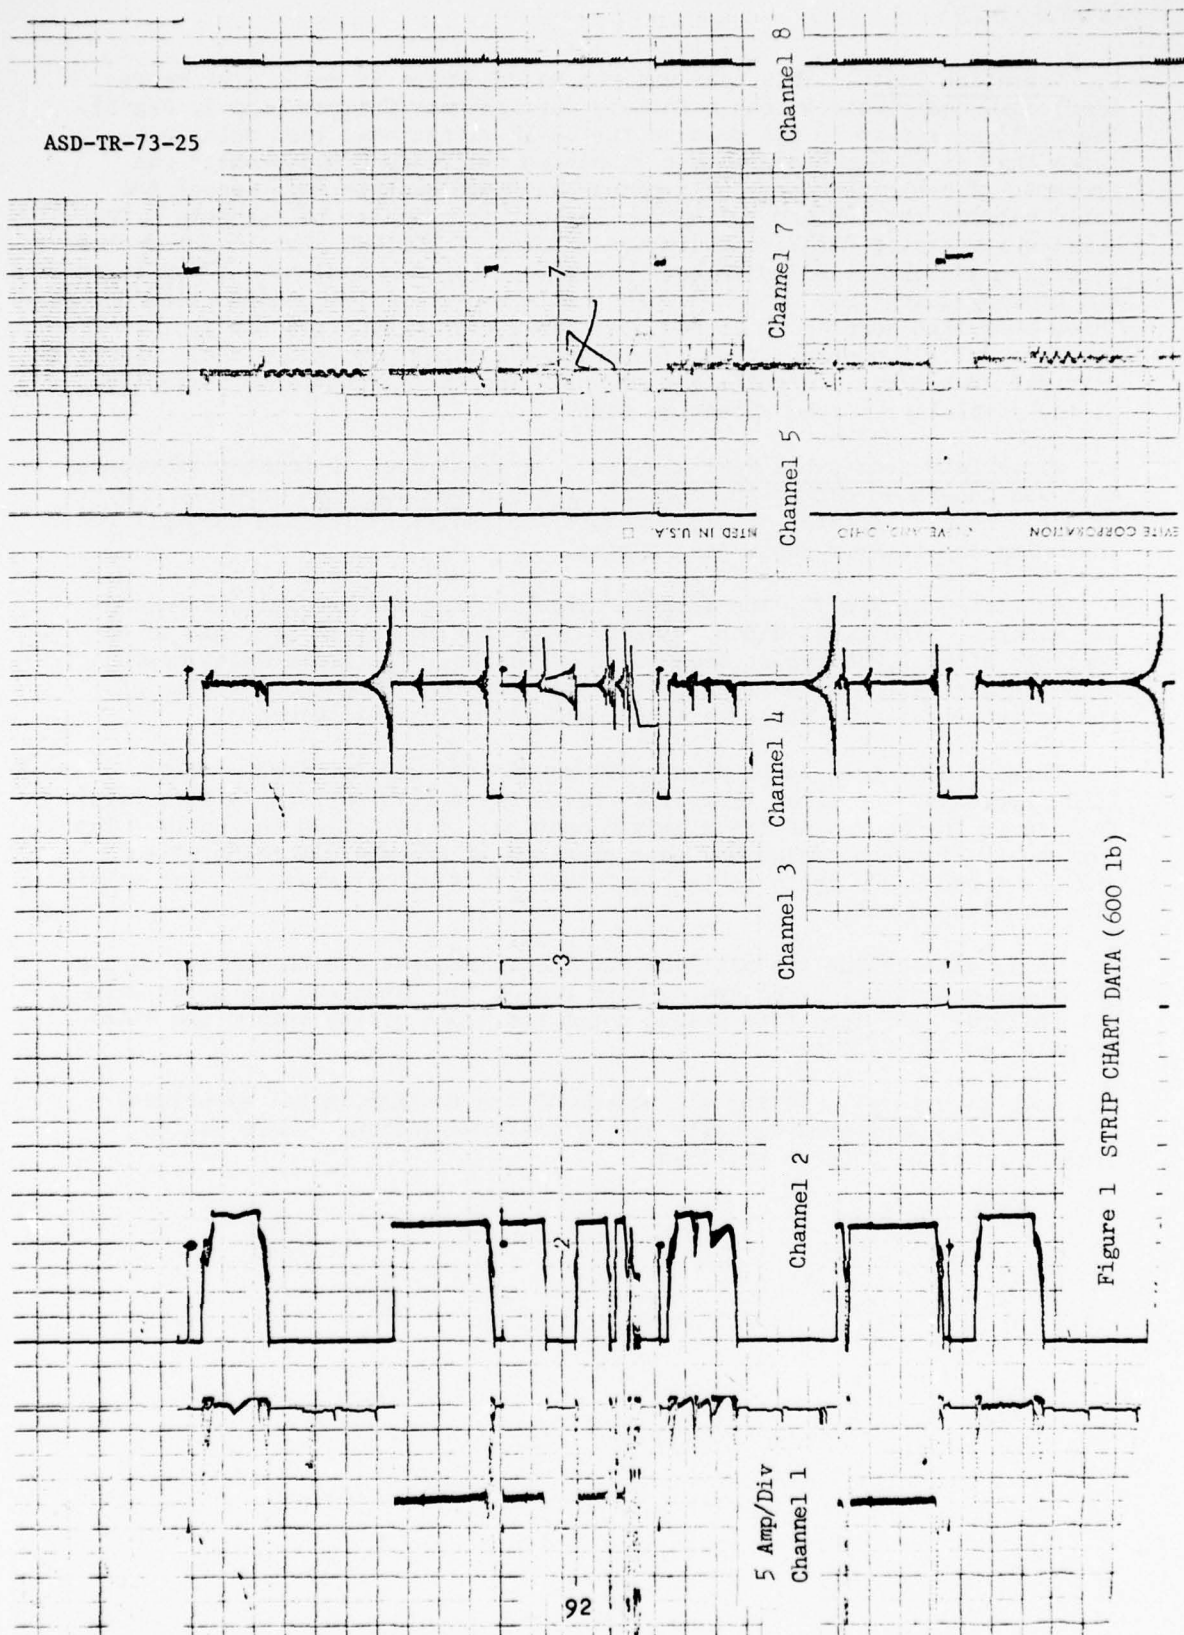
Figure 1 depicts strip chart recorder data for cycles 2800, 2850, and 2900. The motor amperage and voltage (channels 1 and 2) appear erratic compared with Figures 2 and 3, which depict cycles 350, 400, 450, 800, 850, 900, and 950.

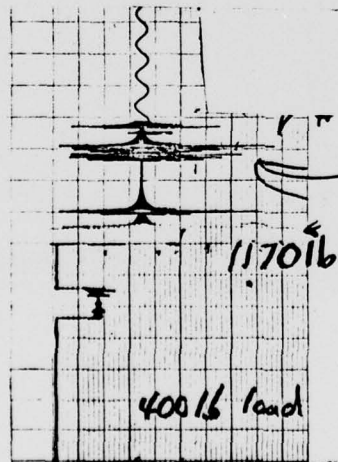
Figure 5 LOAD JOGGING

f. Jogging - Other tests were accomplished to determine the effect of "jogging" the hoist with various loads (Fig 5). This was accomplished by rapidly flipping the hoist on and off, causing the lead weight to jerk or bounce. The cable tension results are given in App II, Tables 1 and 2. Flight tests (App III) were also run to determine these loads in flight. At higher loads (i.e., 600 pounds) the helicopter experienced severe gyrations during hoist jogging. The helicopter acts as a shock absorber at high loads, reducing the G's on the cable. Thus, at 600 pounds the maximum
